**Flood Control Project Maintenance
Levee Inspections**

Maintenance Issue Types Only, Levee Inspection Report By Mile - Spring 2015

Reclamation District No. 2089 Stark

Waterway	Bank	Unit Miles	Inspection Start/End	Inspector
Unit No. 01 Old River	Right	1.51	05/05/2015 05/08/2015	Maksim Khashchuk

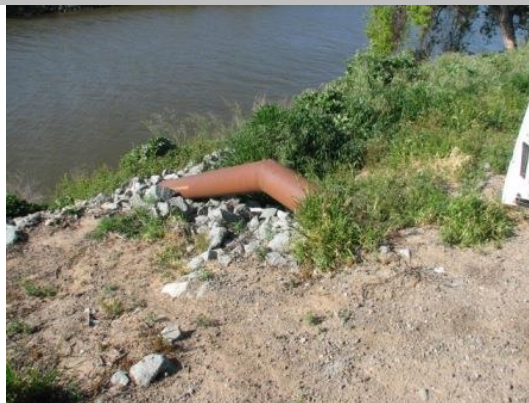
Photo 1 of 1 : SP_2015_RD2089_316_7_20150317_00005.jpg

LM Start	0.04	Rating **	A/W	Issue No.	7
LM End	0.04	Issue Type +	Ma	Location *	LS
Category	Earthen Levee			GPS Latitude/Longitude	
				Start	End
Item	Encroachments			37.811467 °	37.811467 °
				-121.385569 °	-121.385569 °
DWR ID	DWR_RD2089_01_s _ 2012_7				
Action/Comments					
Pipe					
Inspector Comments: Drainage pump

Waterside of drainage discharge to Old River.

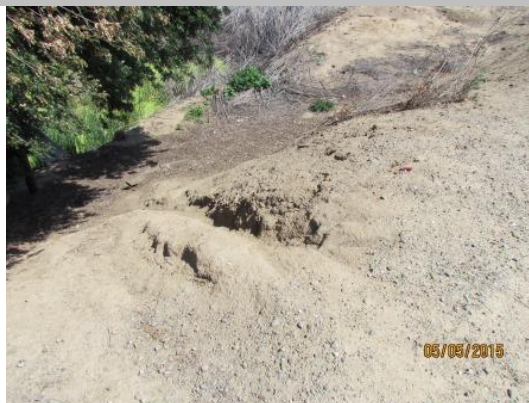
Photo 1 of 1 : SP_2015_RD2089_316_1_20150511_00036.jpg

LM Start	0.04	Rating **	M	Issue No.	1
LM End	0.04	Issue Type +	Ma	Location *	LS
Category	Earthen Levee			GPS Latitude/Longitude	
				Start	End
Item	Encroachments			37.811474 °	37.811474 °
				-121.385573 °	-121.385573 °
DWR ID	DWR_RD2089_01_s _ 2012_1				
Action/Comments					
Stairway					
Inspector Comments: Steps have been cut into the levee slope, this could become an erosion point, please fill and compact.

View of the stairs eroding into the landside levee slope.

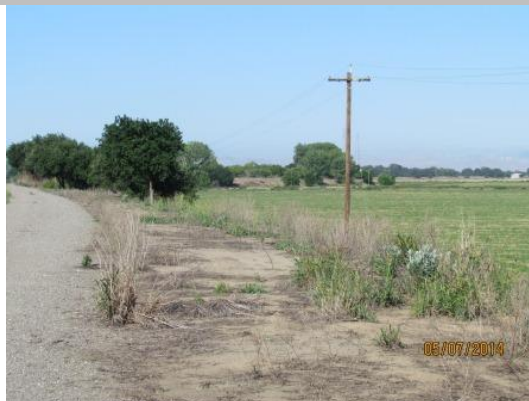
Photo 1 of 1 : SP_2015_RD2089_316_42_20150317_00022.jpg

LM Start	0.07	Rating **	M	Issue No.	42
LM End	0.13	Issue Type +	Ma	Location *	LS
Category	Earthen Levee			GPS Latitude/Longitude	
				Start	End
Item	Vegetation			37.811368 °	37.811048 °
				-121.386085 °	-121.387242 °
DWR ID	DWR_RD2089_01_f _ 2013_42				
Action/Comments					
Remove the wild growth other than native grasses from the levee slopes.

View of the tall vegetation obstructing visibility of the landside levee slope.

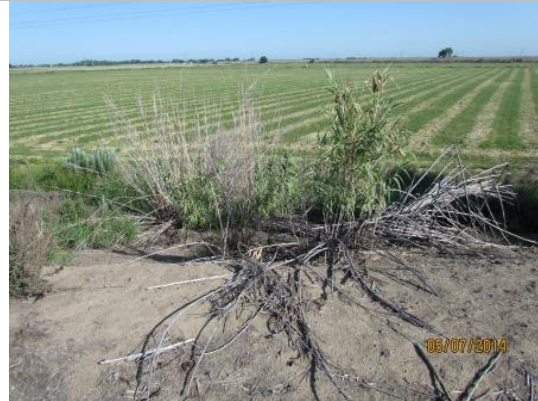
Photo 1 of 1 : SP_2015_RD2089_316_940_20150317_00030.jpg

LM Start	0.24	Rating **	M	Issue No.	940
LM End	0.24	Issue Type +	Ma	Location *	LS
Category	Earthen Levee			GPS Latitude/Longitude	
				Start	End
Item	Vegetation			37.810412 °	37.810412 °
				-121.389115 °	-121.389115 °
DWR ID	DWR_RD2089_01_s _ 2012_940				
Action/Comments					
Remove the wild growth other than native grasses from the levee slopes. Inspector Comments: Arundo has been trimmed back from the crown but still remains as an obstruction to the slope and obstructs visibility, needs to be removed.

The LMA is actively trying to remove the vegetation on the landside levee slope and toe.

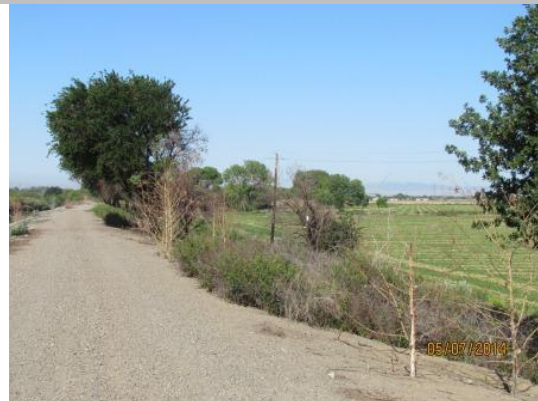
Photo 1 of 1 : SP_2015_RD2089_316_12_20150317_00007.jpg

LM Start	0.27	Rating **	U	Issue No.	12
LM End	0.39	Issue Type +	Ma	Location *	LS
Category	Earthen Levee			GPS Latitude/Longitude	
				Start	End
Item	Vegetation			37.810319 °	37.809740 °
				-121.389510 °	-121.391645 °
DWR ID	DWR_RD2089_01_s _ 2012_12				
Action/Comments					
Remove the wild growth other than native grasses from the levee slopes.					
Inspector Comments: Access and visibility completely blocked.					
11/10/2011 issue has not changed.

Thick brush and wild rose completely block access and visibility of landside slope and toe.

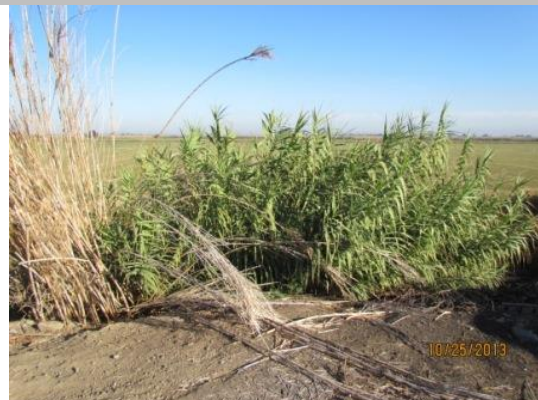
Photo 1 of 1 : SP_2015_RD2089_316_19_20150317_00012.jpg

LM Start	0.34	Rating **	M	Issue No.	19
LM End	0.34	Issue Type +	Ma	Location *	LS
Category	Earthen Levee			GPS Latitude/Longitude	
				Start	End
Item	Vegetation			37.809978 °	37.809978 °
				-121.390704 °	-121.390704 °
DWR ID	DWR_RD2089_01_s _ 2012_19				
Action/Comments					
Remove the wild growth other than native grasses from the levee slopes.					
Inspector Comments: Bamboo completely blocks access and visibility.11/10/2011 Arundo has been trimmed back from the roadway, but still completely blocks access and visibility to the landside slope. This plant was improperly identified as bamboo in previous inspections.

Arundo has been trimmed back from the road, but needs to be removed so that it does not obstruct visibility and access to the landside toe.

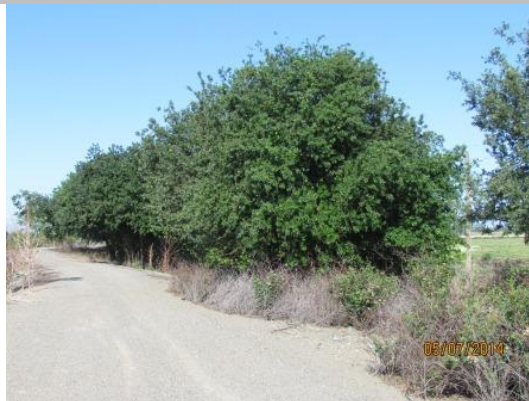
Photo 1 of 1 : SP_2015_RD2089_316_946_20150317_00031.jpg

Trees on levee slope obstruct access and visibility.

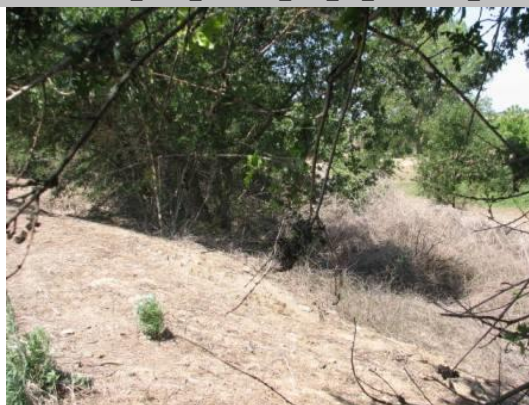
Photo 1 of 1 : SP_2015_RD2089_316_28_20150317_00016.jpg

LM Start	0.41	Rating **	U	Issue No.	28
LM End	0.46	Issue Type +	Ma	Location *	LS
Category	Earthen Levee			GPS Latitude/Longitude	
				Start	End
Item	Vegetation			37.809593 °	37.809507 °
				-121.391963 °	-121.392907 °
DWR ID	DWR_RD2089_01_s _ 2012_28				
Action/Comments					
Remove the wild growth other than native grasses from the levee slopes. Inspector Comments: Vegetation is too thick to allow access and visibility.

05/24/2011 Photo shows thick dead vegetation and continuation of trees in area that are preventing access and visibility of landside slope and toe.

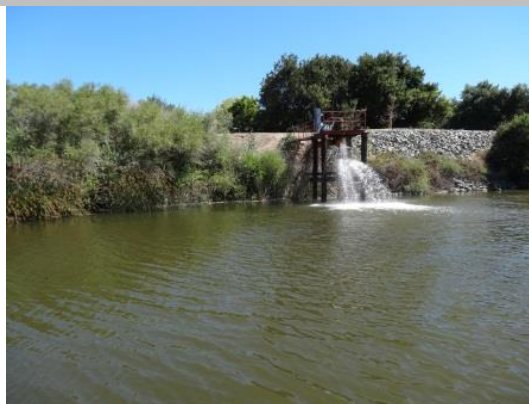
Photo 1 of 1 : SP_2015_RD2089_316_5_20150317_00004.jpg

LM Start	0.46	Rating **	M	Issue No.	5
LM End	0.46	Issue Type +	Ma	Location *	WS
Category	Supplemental			GPS Latitude/Longitude	
				Start	End
Item	DWR Erosion Survey			37.809394 °	37.809394 °
				-121.392791 °	-121.392791 °
DWR ID	DWR_RD2089_01_s _ 2015_5				
Action/Comments					
Inspector Comments: 07/02/2014: No significant change observed. 08/13/2013: No significant change observed. 08/07/2012: The site has been visited by boat survey. No significant change observed 08/23/2011: The site shows loose material around the pipe crossing. The operation of the pipe might have caused an impact on the levee. [2014 Site ID:RD2089U01RM29.8]

Front view of the site.

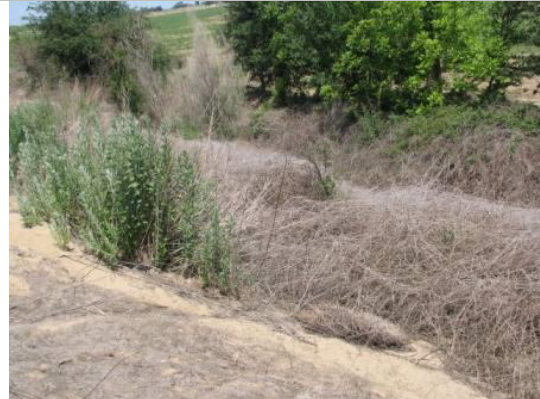
Photo 1 of 1 : SP_2015_RD2089_316_30_20150317_00017.jpg

05/24/2011 Dead brush is too thick to allow access and visibility of landside slope and toe.

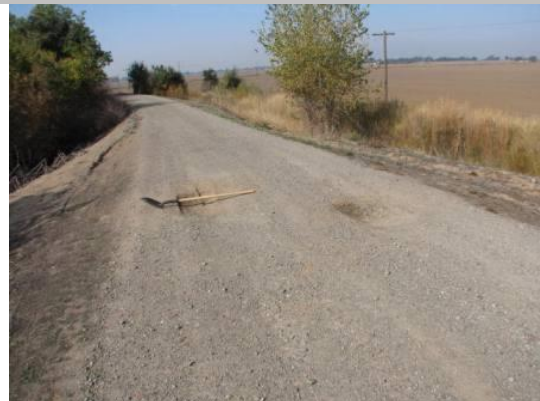
Photo 1 of 1 : SP_2015_RD2089_316_14_20150317_00008.jpg

LM Start	0.54	Rating **	M	Issue No.	14
LM End	0.54	Issue Type +	Ma	Location *	CR
Category	Earthen Levee			GPS Latitude/Longitude	
				Start	End
Item	Crown Surface / Depressions / Rutting			37.810087 °	37.810087 °
				-121.394200 °	-121.394200 °
DWR ID	DWR_RD2089_01_s _ 2012_14				
Action/Comments					
Add appropriate gravel or road base. Grade and compact.					
Inspector Comments: 11/10/2011 Minor depressions will cause ponding.

11/10/2011 Depressions in crown.

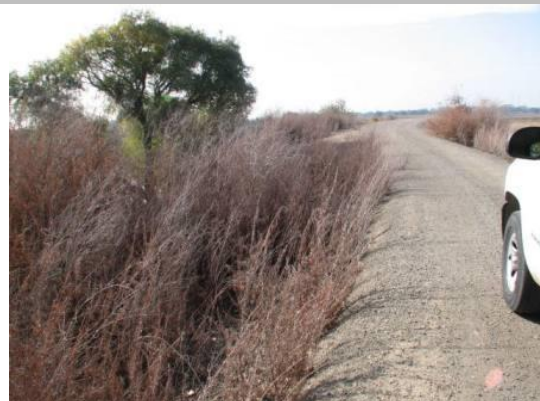
Photo 1 of 1 : SP_2015_RD2089_316_18_20150317_00011.jpg

LM Start	0.63	Rating **	M	Issue No.	18
LM End	1.49	Issue Type +	Ma	Location *	WS
Category	Earthen Levee			GPS Latitude/Longitude	
				Start	End
Item	Vegetation			37.810048 °	37.806534 °
				-121.395762 °	-121.407531 °
DWR ID	DWR_RD2089_01_s _ 2012_18				
Action/Comments					
Remove the wild growth other than native grasses from the levee slopes.					
Inspector Comments: 11/10/2011 Waterside vegetation is too thick to allow access and visibility.

11/10/2011 Vegetation needs to be cleared on the upper 20' of the waterside slope.

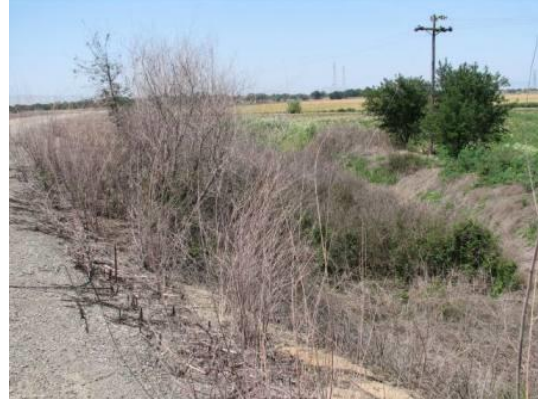
Photo 1 of 1 : SP_2015_RD2089_316_31_20150317_00018.jpg

05/24/2011 Vegetation is mostly dead but needs to be removed to allow access and visibility of slope and toe.

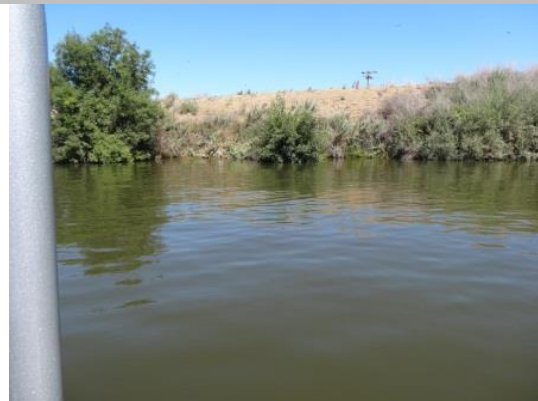
Photo 1 of 1 : SP_2015_RD2089_316_3_20150317_00003.jpg

LM Start	0.67	Rating **	U	Issue No.	3
LM End	0.67	Issue Type +	Ma	Location *	WS
Category	Supplemental			GPS Latitude/Longitude	
				Start	End
Item	DWR Erosion Survey			37.809780 °	37.809780 °
				-121.396230 °	-121.396230 °
DWR ID	DWR_RD2089_01_s_2015_3				
Action/Comments					
Inspector Comments: 07/02/2014: No significant change observed. 08/13/2013: No significant change observed. 08/07/2012: The site has been visited by boat survey. No significant change observed 08/23/2011: The 5-foot vertical scarp shows no significant change from the last year inspection. No new erosion activities observed. Dense white willow trees on site. 09/07/2010: It was difficult to view the erosion due to the thick Willow thickets and other vegetation at the water line. At the time of the inspection, there were no signs of repair on site. As noted during the last survey, there is a 5-foot vertical scarp along the lower slope that may be subjected to high flow velocities. 08/05/2010: Recommended for repair, per CLRO; "Erosion of this site may be subjective to rapid rates of erosion." 09/28/2009: No major change observed; 5-foot vertical scarp is immediately downstream of where berm has tapered; site is recommended as local maintenance issue, per CLRO CES Evaluation 2008 Report; Site # is the same as RM29.6, LM0.60; previously rated "U". 11/05/2008: No change observed; rodent holes on lower slope; wide levee crown. [2014 Site ID:RD2089U01RM29.61]

Front view of the site. The scarp is visible on the slope.

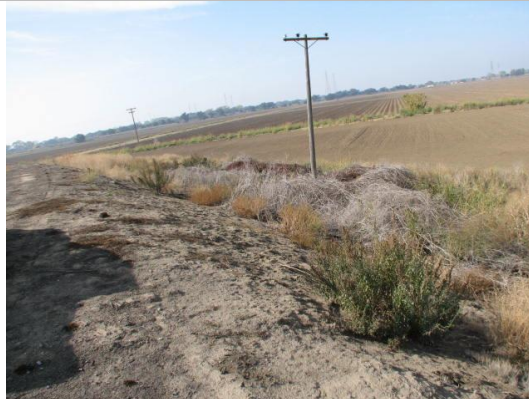
Photo 1 of 1 : SP_2015_RD2089_316_20_20150317_00013.jpg

11/10/2011 Vegetation obstructs visibility of slope and toe.

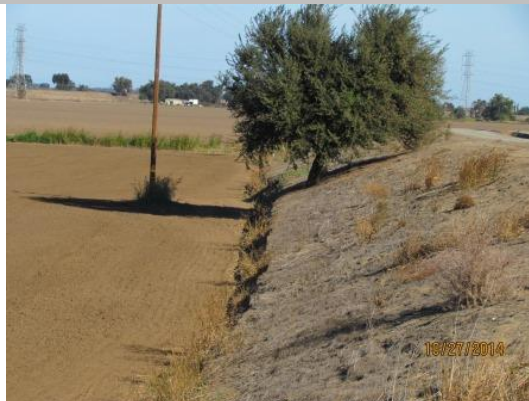
Photo 1 of 1 : SP_2015_RD2089_316_17_20150317_00010.jpg

LM Start	0.81	Rating **	M	Issue No.	17
LM End	0.94	Issue Type +	Ma	Location *	LS
Category	Earthen Levee			GPS Latitude/Longitude	
				Start	End
Item	Slope Stability			37.808319 °	37.806453 °
				-121.397881 °	-121.397755 °
DWR ID	DWR_RD2089_01_f _ 2014_17				
Action/Comments					
Repair slope instability.					
Inspector Comments: Landside levee toe cut due to farming.

View of the vertical cut along the landside levee toe.

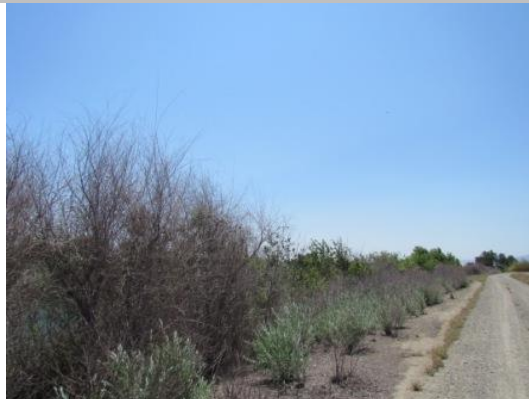
Photo 1 of 1 : SP_2015_RD2089_316_36_20150317_00021.jpg

LM Start	0.83	Rating **	M	Issue No.	36
LM End	0.94	Issue Type +	Ma	Location *	WS
Category	Earthen Levee			GPS Latitude/Longitude	
				Start	End
Item	Vegetation			37.807938 °	37.806361 °
				-121.397898 °	-121.397778 °
DWR ID	DWR_RD2089_01_s _ 2012_36				
Action/Comments					
Remove the wild growth other than native grasses from the levee slopes.					
Inspector Comments: Tall weeds and brush on top 20' of waterside slope obstruct visibility.

View of tall weeds and brush obstructing visibility on waterside slope.
05/24/2012

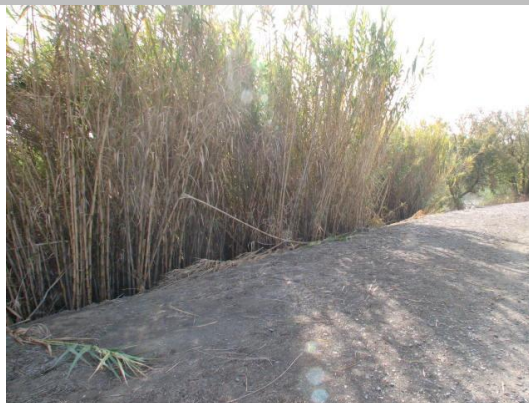
Photo 1 of 1 : SP_2015_RD2089_316_33_20150317_00019.jpg

11/10/2011 Arundo on upper 20' of waterside slope.

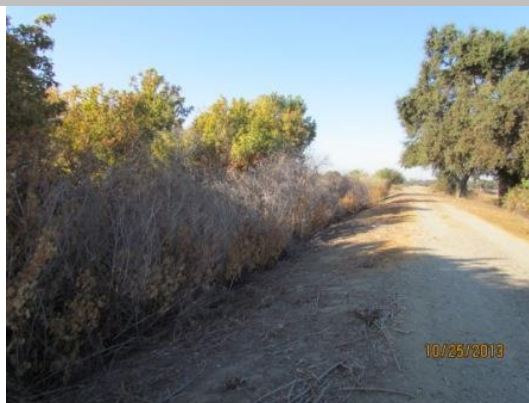
Photo 1 of 1 : SP_2015_RD2089_316_35_20150317_00020.jpg

Thick vegetation on upper 20' of waterside slope obstructing visibility and access.

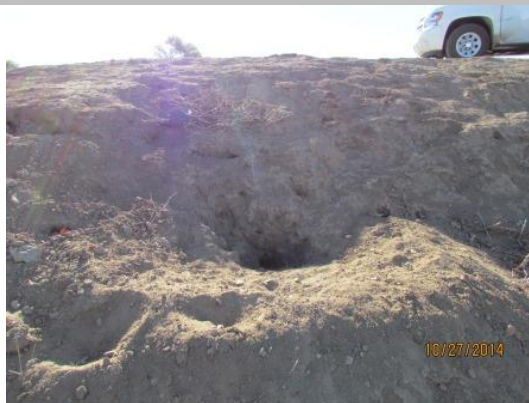
Photo 1 of 1 : SP_2015_RD2089_316_16_20150317_00009.jpg

View of the rodent burrow on the landside levee slope.

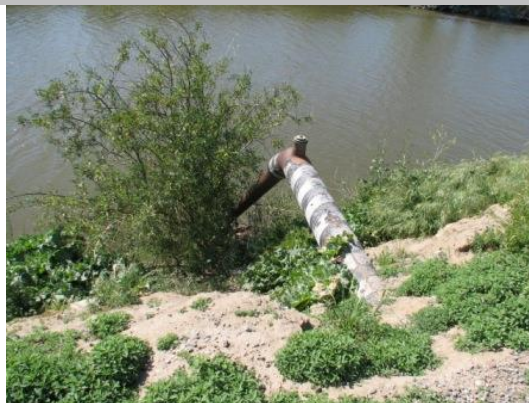
Photo 1 of 1 : SP_2015_RD2089_316_21_20150317_00014.jpg

Drainage discharge into Old River.

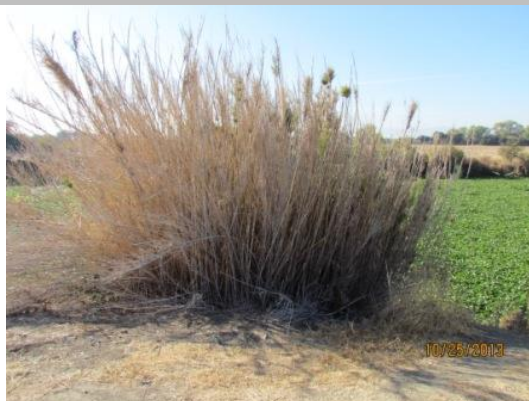
Photo 1 of 1 : SP_2015_RD2089_316_25_20150317_00015.jpg

View of the Arundo on the waterside slope obstructing visibility. LMA is actively trying to remove the wild growth.

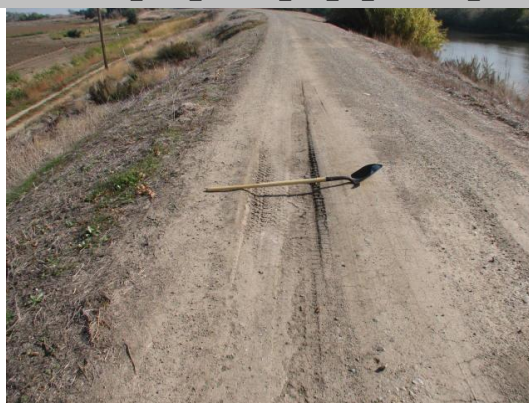
Photo 1 of 1 : SP_2015_RD2089_316_43_20150317_00023.jpg

11/10/2011 Depression in roadway.

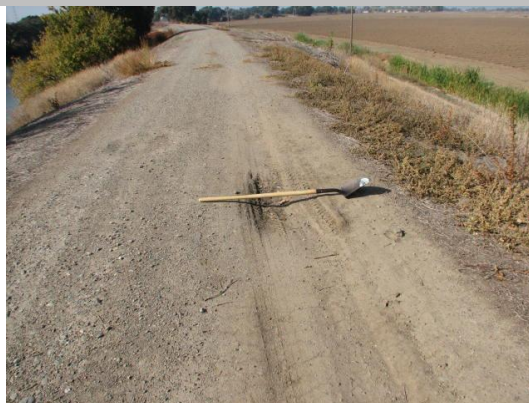
Photo 1 of 1 : SP_2015_RD2089_316_44_20150317_00024.jpg

11/10/2011 Roadway depression.

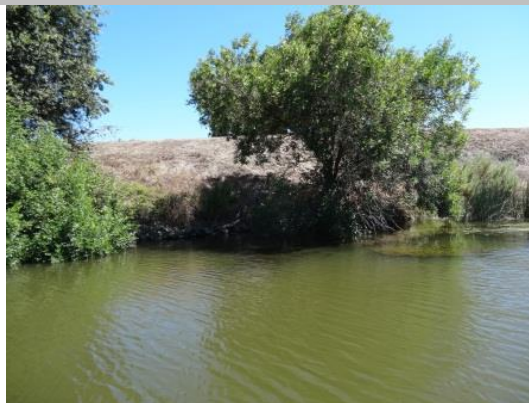
Photo 1 of 1 : SP_2015_RD2089_316_2_20150317_00002.jpg

LM Start	1.23	Rating **	M	Issue No.	2
LM End	1.23	Issue Type +	Ma	Location *	WS
Category	Supplemental			GPS Latitude/Longitude	
				Start	End
Item	DWR Erosion Survey			37.805580 °	37.805580 °
				-121.403010 °	-121.403010 °
DWR ID	DWR_RD2089_01_s _ 2015_2				
Action/Comments					
Inspector Comments: 07/02/2014: No significant change observed. 08/13/2013: The erosion is around a tree at the levee toe. Dense vegetation is visible. [2014 Site ID:RD2089U01RM29.04]

Close view of the site. Note the tree and the vegetation.

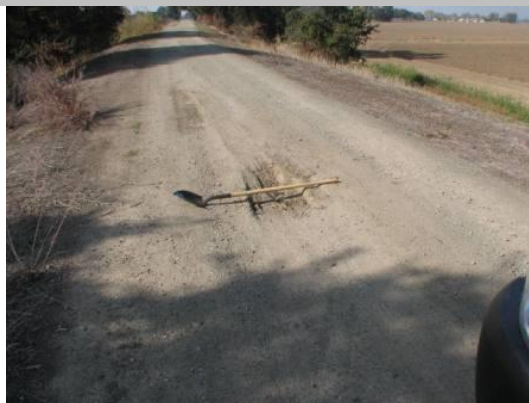
Photo 1 of 1 : SP_2015_RD2089_316_45_20150317_00025.jpg

11/10/2011 Roadway depression.

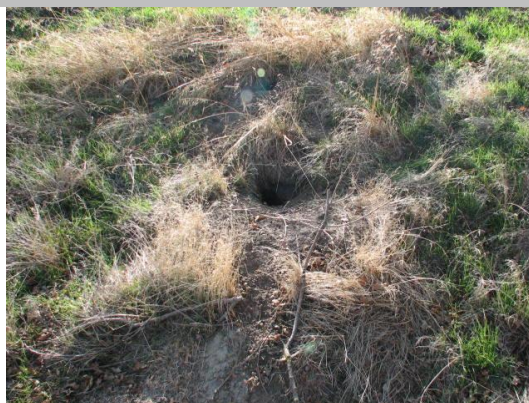
Photo 1 of 1 : SP_2015_RD2089_316_47_20150317_00027.jpg

11/10/2011 Active rodent burrow on landside slope.

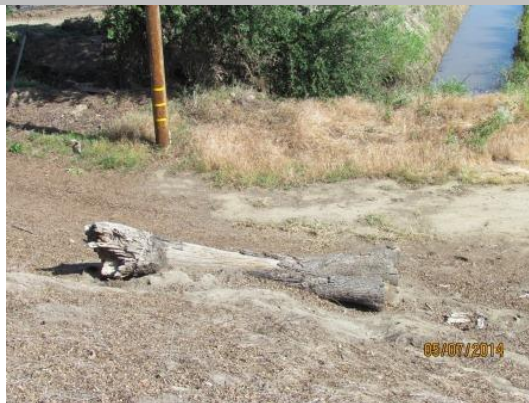
Photo 1 of 1 : SP_2015_RD2089_316_46_20150317_00026.jpg

Decaying tree at the landside levee toe is obstructing visibility and access.

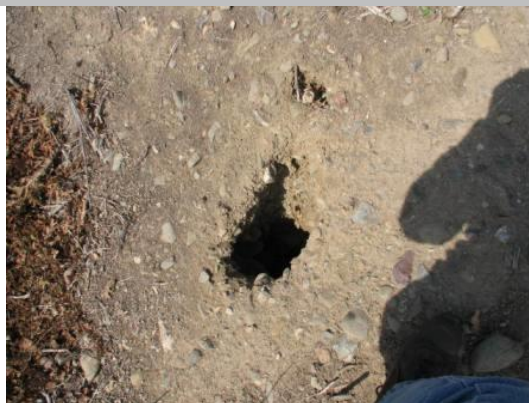
Photo 1 of 1 : SP_2015_RD2089_316_49_20150317_00028.jpg

11/10/2011 Deep burrow on waterside.

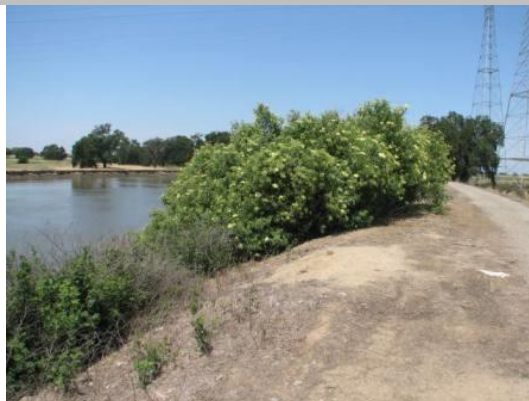
Photo 1 of 2 : SP_2015_RD2089_317_4_20150317_00003.jpg

05/24/2011 Updated photo of issue noted in Fall 2010 inspection.

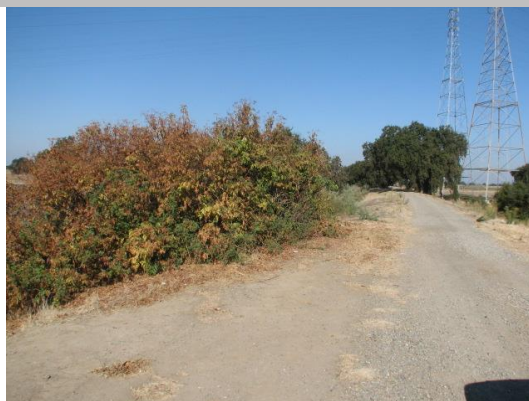
Photo 2 of 2 : SP_2015_RD2089_317_4_20150317_00004.jpg

Fall 2009 photo of unacceptable vegetation on levee slope.

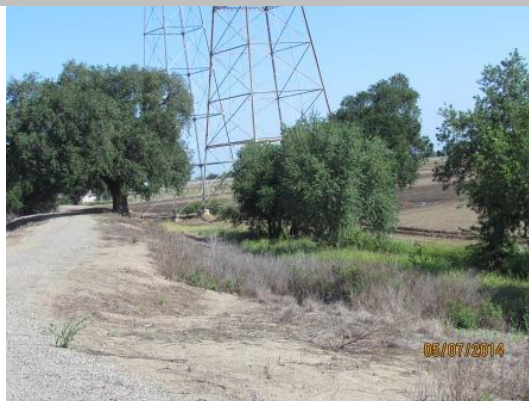
Photo 1 of 1 : SP_2015_RD2089_317_19_20150317_00019.jpg

View of the vegetation on the landside levee slope.

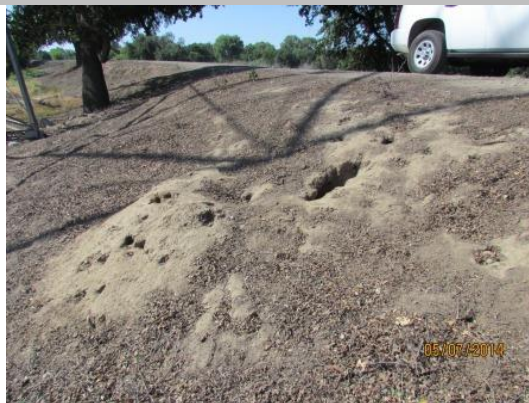
Photo 1 of 1 : SP_2015_RD2089_317_48_20150317_00029.jpg

View of the rodent burrow on the landside levee slope.

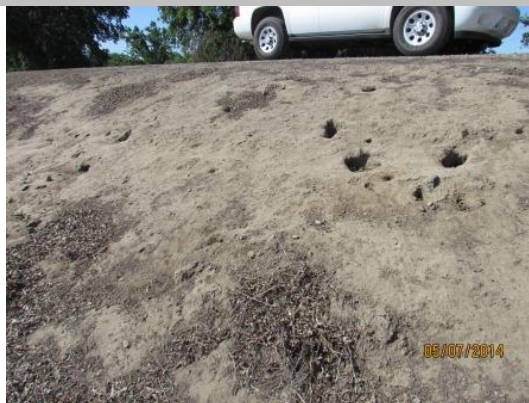
Photo 1 of 1 : SP_2015_RD2089_317_49_20150317_00030.jpg

View of the multiple rodent burrows on the landside levee hinge and slope.

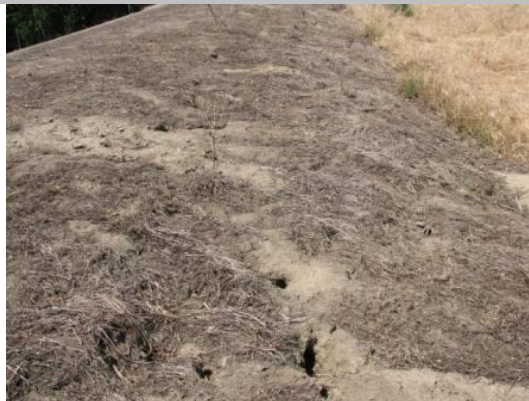
Photo 1 of 1 : SP_2015_RD2089_317_24_20150317_00021.jpg

05/24/2011 Active burrows, ground squirrel sighted in area.

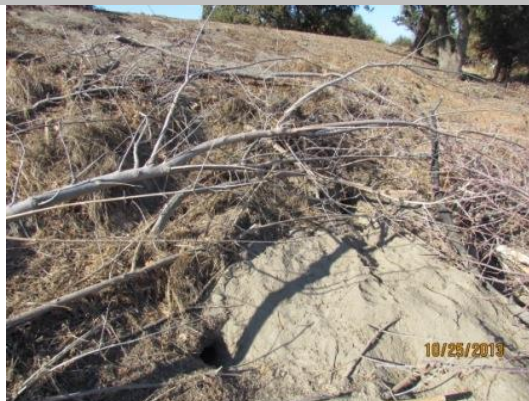
Photo 1 of 1 : SP_2015_RD2089_317_51_20150317_00031.jpg

View of the rodent burrow on the landside levee toe.

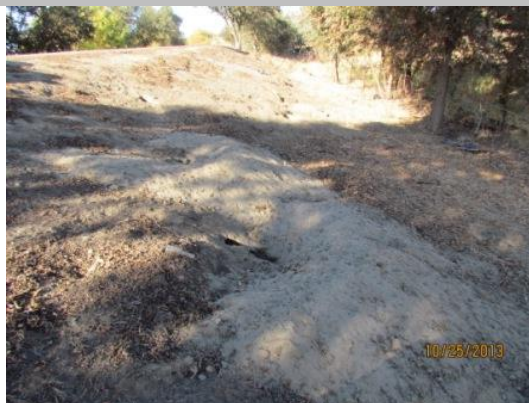
Photo 1 of 3 : SP_2015_RD2089_317_53_20150317_00033.jpg

LM Start	0.30	Rating **	U	Issue No.	53
LM End	0.31	Issue Type +	Ma	Location *	LS
Category	Earthen Levee			GPS Latitude/Longitude	
				Start	End
Item	Animal Control			37.809977 °	37.810022 °
				-121.411189 °	-121.411387 °
DWR ID	DWR_RD2089_02_f_2013_53				
Action/Comments					
Exterminate rodents and backfill and compact or grout burrows. Inspector Comments: Exterminating rodents and grouting the burrows recommended.

View of the multiple rodent burrows on the landside levee slope.

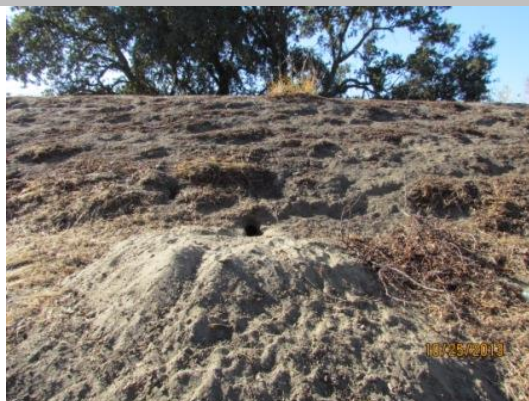
Photo 2 of 3 : SP_2015_RD2089_317_53_20150317_00034.jpg

View of the rodent burrow on the landside levee slope.

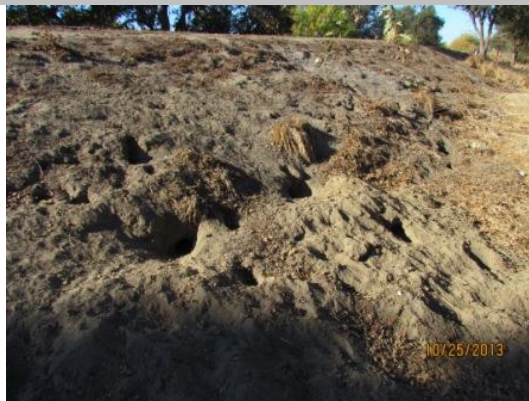
Photo 3 of 3 : SP_2015_RD2089_317_53_20150317_00035.jpg

LM Start	0.30	Rating **	U	Issue No.	53 (cont)	
LM End	0.31	Issue Type +	Ma	Location *	LS	
Category	Earthen Levee			GPS Latitude/Longitude		
				Start		End
Item	Animal Control			37.809977 °		37.810022 °
				-121.411189 °		-121.411387 °
DWR ID	DWR_RD2089_02_f_2013_53					
Action/Comments						
Exterminate rodents and backfill and compact or grout burrows. Inspector Comments: Exterminating rodents and grouting the burrows recommended.

Another view of the multiple rodent burrows on the landside levee slope.

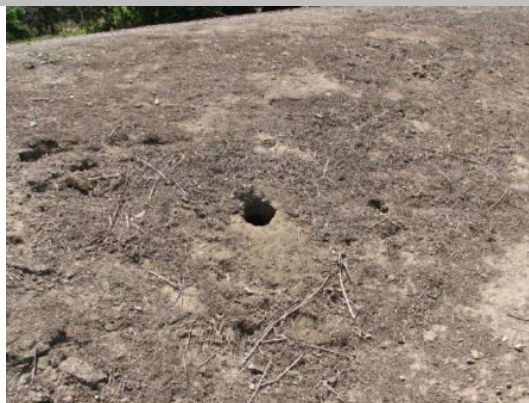
Photo 1 of 1 : SP_2015_RD2089_317_26_20150317_00022.jpg

LM Start	0.36	Rating **	M	Issue No.	26
LM End	0.36	Issue Type +	Ma	Location *	LS
Category	Earthen Levee			GPS Latitude/Longitude	
				Start	End
Item	Animal Control			37.810125 °	37.810125 °
				-121.412317 °	-121.412317 °
DWR ID	DWR_RD2089_02_s_2012_26				
Action/Comments					
No rodents visible, but rodent burrows visible; need to backfill and compact or grout burrows.					
Inspector Comments: Active burrow needs to be repaired.

05/24/2011 Active rodent burrow.

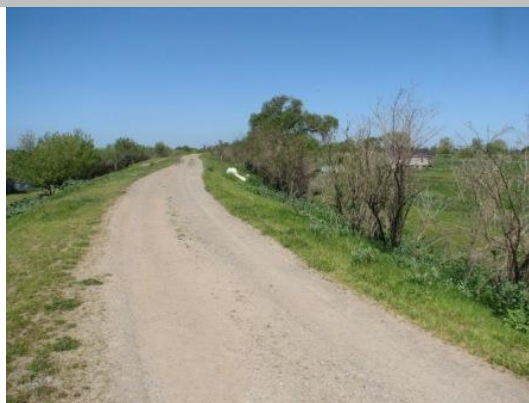
Photo 1 of 2 : SP_2015_RD2089_317_8_20150317_00008.jpg

Brush on landside slope limits access.

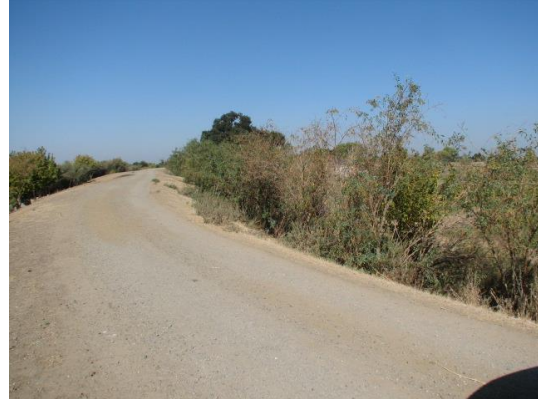
Photo 2 of 2 : SP_2015_RD2089_317_8_20150317_00009.jpg

Fall 2009 photo: Brush on landside toe limits visibility and accessibility.

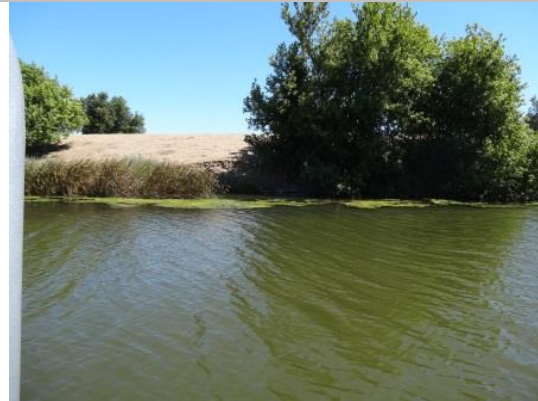
Photo 1 of 1 : SP_2015_RD2089_317_1_20150317_00001.jpg

LM Start	0.40	Rating **	M	Issue No.	1
LM End	0.40	Issue Type +	Ma	Location *	WS
Category	Supplemental			GPS Latitude/Longitude	
				Start	End
Item	DWR Erosion Survey			37.809960 °	37.809960 °
				-121.413200 °	-121.413200 °
DWR ID	DWR_RD2089_02_s _ 2015_1				
Action/Comments					
Inspector Comments: 07/02/2014: No significant change observed. 08/13/2013: No significant change observed. 08/07/2012: The site has been visited by boat survey. No significant change observed. 08/23/2011: No significant change observed on site. 09/07/2010: Site consists of a jutting rip rap that has created an eddy, scouring the levee slope. Most sections of the toe and lower slope are lined with rip rap. However, the rip rap is sloughing on the mid slope and at the toe, exposing the underlying soils and tree roots. The remaining revetment is no longer adequately protecting the slope. There are 3 Sycamore trees at the toe with exposed tree roots. 08/05/2010: Recommended for repair, per CLRO. 09/28/2009: Pocket erosion on lower slope just above the toe rip rap; protruding rip rap upstream is creating an eddy, scouring the levee slope; Site # is the same as RM28.40,LM0.30; previously rated "U"; pictures will be made available during the next survey. 11/05/2008: Cut into levee profile; riprap slide; rodent holes; pictures do not match GPS and current condition. [2014 Site ID:RD2089U02RM28.35]

View of the site from the survey boat.

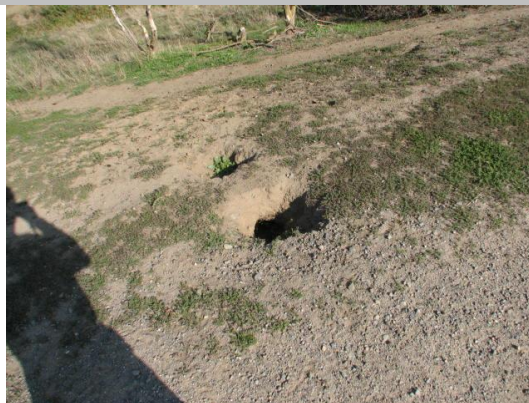
Photo 1 of 1 : SP_2015_RD2089_317_13_20150317_00015.jpg

11/10/2011 Two large burrows on crown, need to be filled.

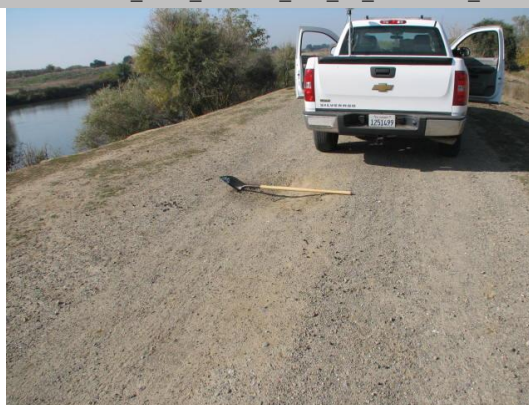
Photo 1 of 1 : SP_2015_RD2089_317_10_20150317_00011.jpg

11/10/2011 Depression in crown needs to be filled.

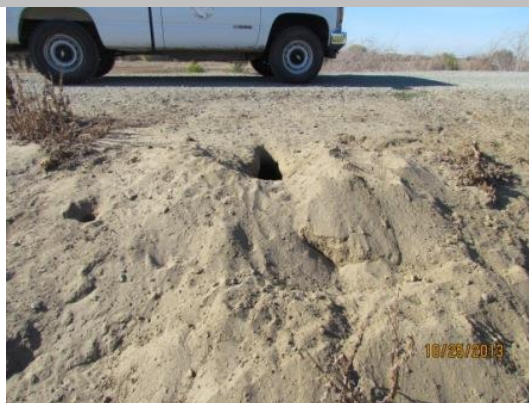
Photo 1 of 1 : SP_2015_RD2089_317_54_20150317_00036.jpg

View of the rodent burrow on the landside levee slope.

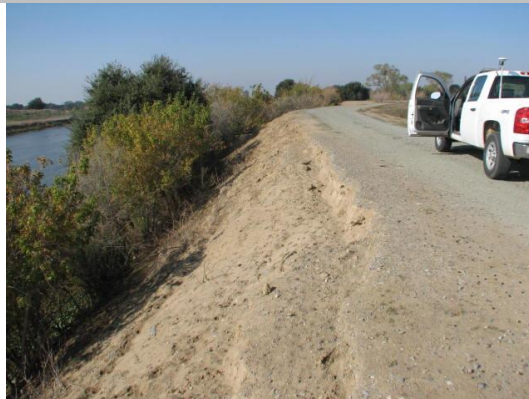
Photo 1 of 1 : SP_2015_RD2089_317_14_20150317_00016.jpg

LM Start	0.52	Rating **	U	Issue No.	14
LM End	0.52	Issue Type +	Ma	Location *	WS
Category	Earthen Levee			GPS Latitude/Longitude	
				Start	End
Item	Animal Control			37.811150 °	37.811150 °
				-121.414748 °	-121.414748 °
DWR ID	DWR_RD2089_02_s_2012_14				
Action/Comments					
Repair the levee slope damaged by livestock and prevent large animal access.					
Inspector Comments: 11/10/2011 Repair damage to slope caused by livestock.

11/10/2011 Approximately 1' scarp has been created by livestock travel.

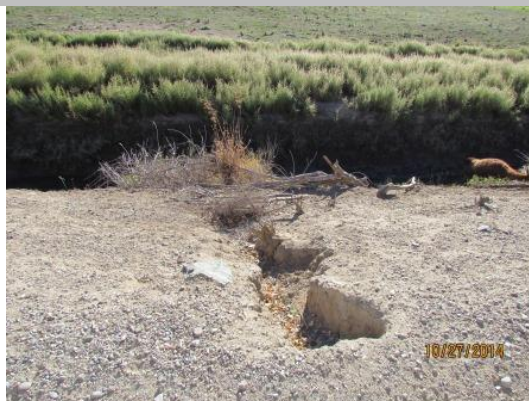
Photo 1 of 1 : SP_2015_RD2089_317_15_20150317_00017.jpg

LM Start	0.77	Rating **	M	Issue No.	15
LM End	0.77	Issue Type +	Ma	Location *	LS
Category	Earthen Levee			GPS Latitude/Longitude	
				Start	End
Item	Slope Stability			37.813969 °	37.813969 °
				-121.414324 °	-121.414324 °
DWR ID	DWR_RD2089_02_f_2014_15				
Action/Comments					
Repair slope instability.

View of the scour from surface runoff on the landside levee slope.

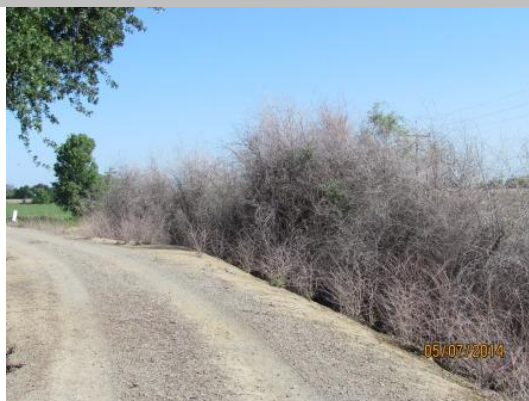
Photo 1 of 1 : SP_2015_RD2089_317_36_20150317_00025.jpg

Extremely thick dead brush prevents access and visibility.

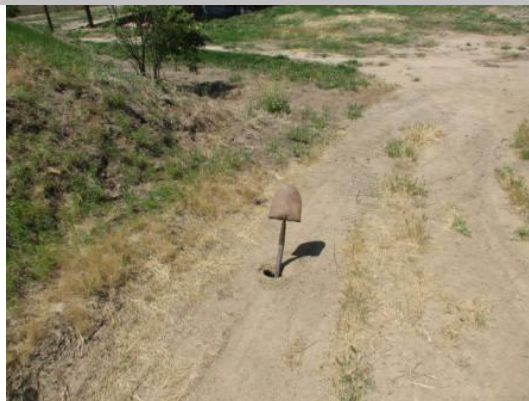
Photo 1 of 2 : SP_2015_RD2089_317_40_20150317_00026.jpg

05/24/2011 Deep vertical burrow in ramp on land side of levee.

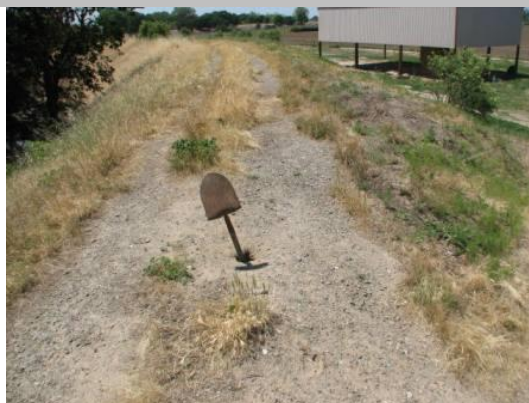
Photo 2 of 2 : SP_2015_RD2089_317_40_20150317_00027.jpg

05/24/2011 Deep vertical burrow in levee crown.

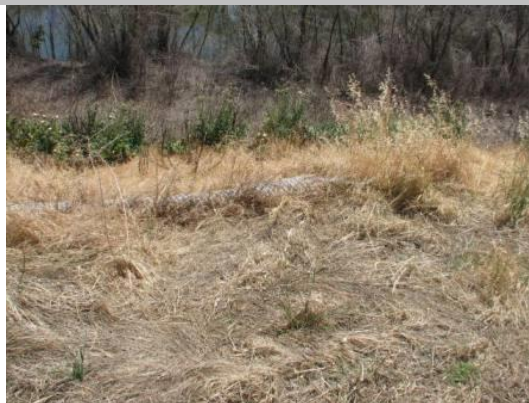
Photo 1 of 1 : SP_2015_RD2089_317_41_20150317_00028.jpg

05/24/2011 Old CMP left on waterside levee slope, needs to be removed.

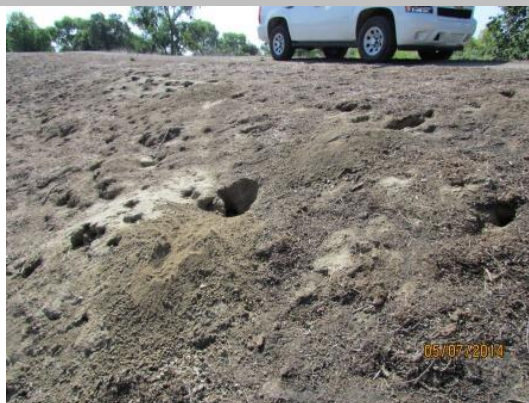
Photo 1 of 1 : SP_2015_RD2089_317_5_20150317_00005.jpg

View of the rodent holes on the landside levee slope.

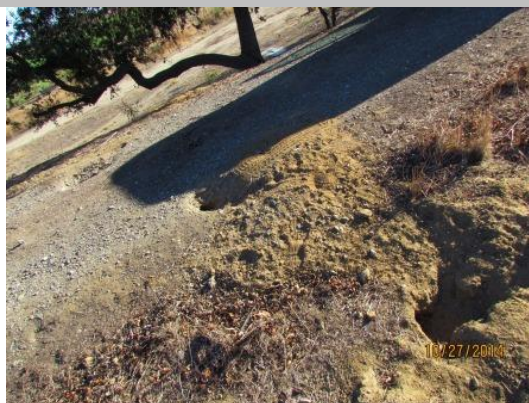
Photo 1 of 2 : SP_2015_RD2089_317_12_20150317_00013.jpg

View of several large rodent holes on the levee crown.

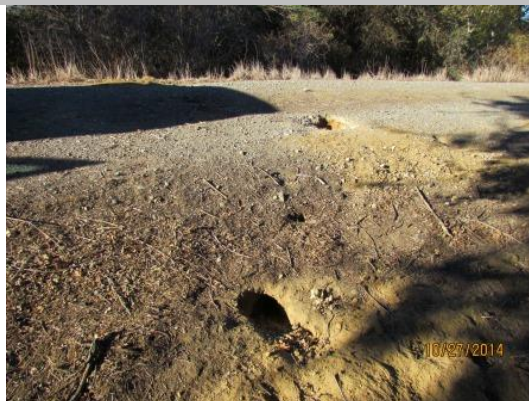
Photo 2 of 2 : SP_2015_RD2089_317_12_20150317_00014.jpg

View of several rodent burrows on landside levee hinge and crown.

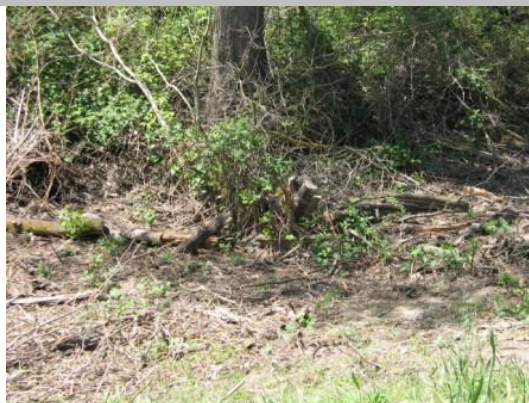
Photo 1 of 1 : SP_2015_RD2089_317_29_20150317_00024.jpg

Tree stump >2" left after vegetation and tree removal.

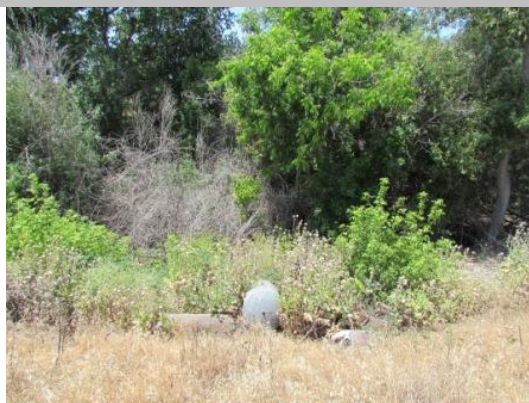
Photo 1 of 1 : SP_2015_RD2089_317_17_20150317_00018.jpg

View of water tanks disposed on waterside slope.

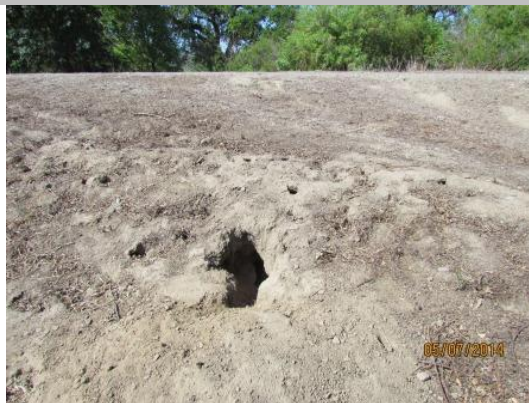
Photo 1 of 1 : SP_2015_RD2089_317_6_20150317_00006.jpg

View of the large rodent hole on the landside levee slope.

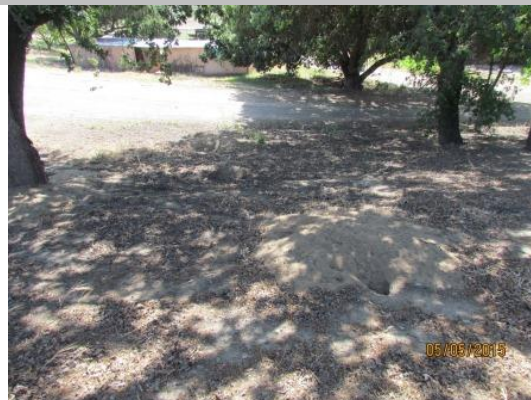
Photo 1 of 1 : SP_2015_RD2089_317_11_20150511_00039.jpg

View of the multiple rodent burrows on the landside levee slope.
